Inspection #0001015

Visual Home Inspection Report

101 Main Street, Eureka, CA

Inspected on: 11/15/2007

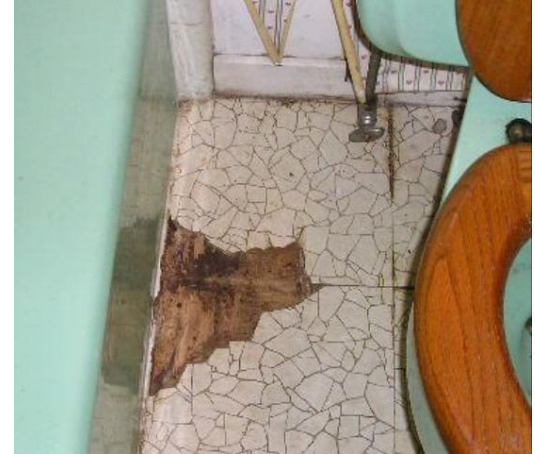
ACTION ITEM: Staining/discoloration and deterioration was noted near the toilet, which is likely due to moisture intrusion. Recommend further evaluation and repair as required by a qualified tradesperson.

Bathroom floor damage
